## **City of St. Zotique**

Squeeze-off water line isolation technique saves time and money for city water line repair.

# REHAU “squeeze-off” technique saves time and money in pipe repair

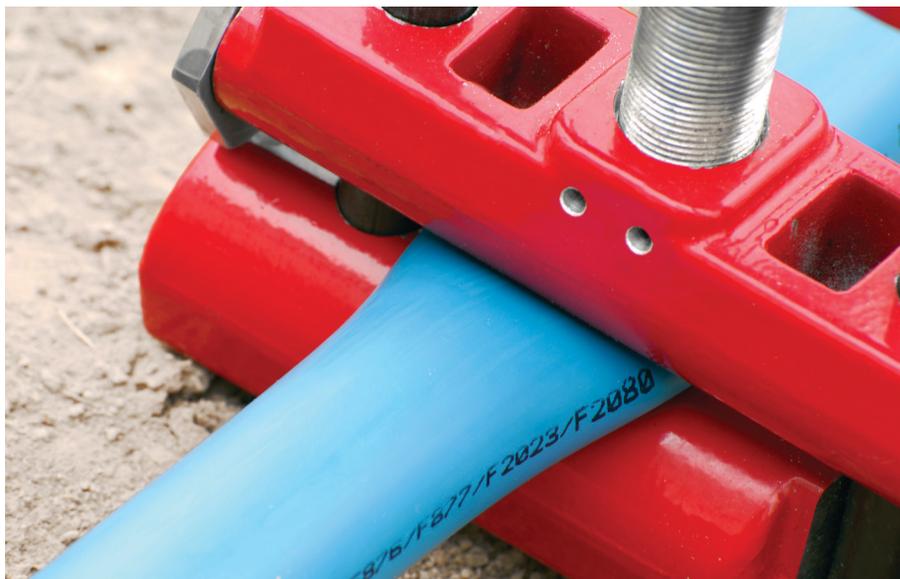
Tasillo recommended using REHAU’s “squeeze-off” procedure to temporarily stop the water flow. “The high strength and flexibility of PEXa pipe allows it to withstand temporary deformation without permanent damage,” explains Tasillo. “Squeezing the pipe flat, using a specialized tool designed for PE gas pipes, would stop the water flow. The valve could then be removed and reinstalled. It would be a simple process, backed by REHAU.”

The city and work crew agreed to try the new method. Tasillo joined the work crew in the trench. “I was confident in my suggestion to use the procedure and wanted to demonstrate that to the crew first-hand,” said Tasillo. “The repair went very well.”

After the curb valve was repaired, the squeeze-off tool was opened carefully and the water started to flow while the pipe returned to its original round shape. The job was completed in 20 minutes, at zero cost to the city of St. Zotique and with no disruption to the customers.
